# Manhole Inspection Summary

Manhole # S51E\_\_020MH

**Location** Address: **rear 2 n curley st**

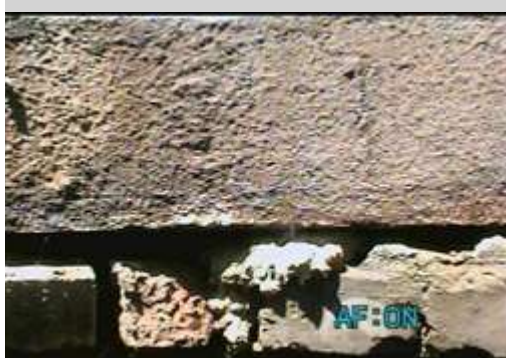
Defect 2

Condition: ☐ Sound ☐ Cracked ☐ Root Intrusion ☐ Loose Brick ☒ **Deteriorated**

chimney cond deteriorated

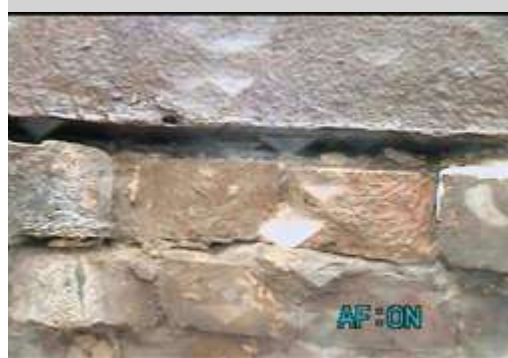
Defect 1

Condition: ☐ Sound ☐ Cracked ☐ Root Intrusion ☐ Loose Brick ☒ **Deteriorated**

corbel

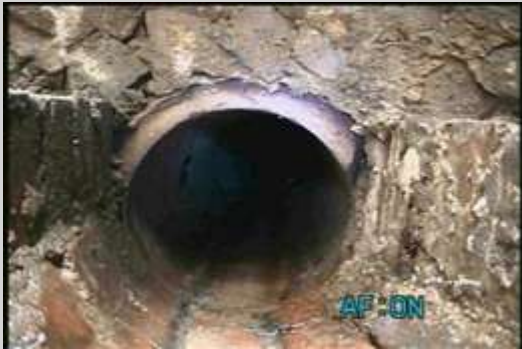
12 O'Clock Outflow

8 in. Circular Gravity Sewer  
Pipe Out @ 12 O'Clock

Invert Depth: 5.01 (ft.) Flow Characteristics: **Slow**

Deposits: ☒ None ☐ Mud ☐ Sludge ☐ Debris ☐ Grease

Infiltration: **None** Pipe Seal Cond: **Unknown**

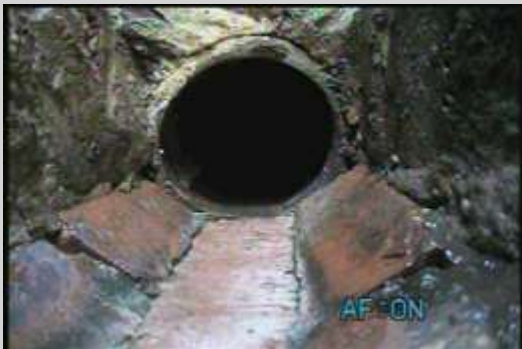
3 O'Clock Inflow

6 in. Circular Gravity Sewer  
Pipe In @ 3 O'Clock

Invert Depth: 4.10 (ft.) Flow Characteristics: **Slow**

Deposits: ☒ None ☐ Mud ☐ Sludge ☐ Debris ☐ Grease

Infiltration: **None** Pipe Seal Cond: **Unknown**
